ADVANCED EROSION PROTECTION TECHNOLOGY EXTENDS THE LIFE OF STEAM BOILER SUPERHEATER TUBES

Mike Palmer
American Electric Power Company
Route 33 West
New Haven, West Virginia 25265

K. Scott Trunkett
Conforma Clad Inc.
501 Park East Boulevard
New Albany, Indiana 47150

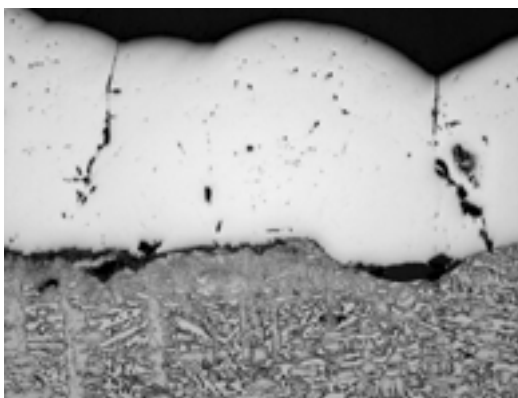
Figure 1. Typical Flame Spray at 100 μm

(Note: maximum coating thickness approximately 15 mils)

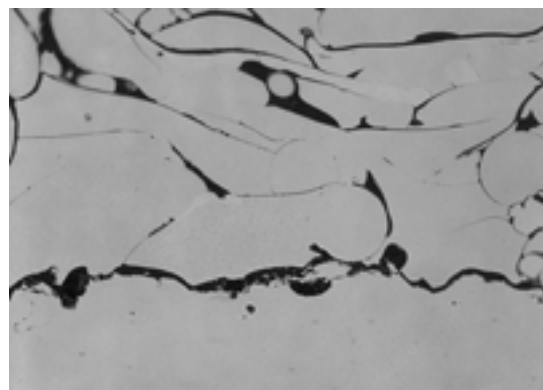
Figure 2. Typical Flame Spray at 10 μm

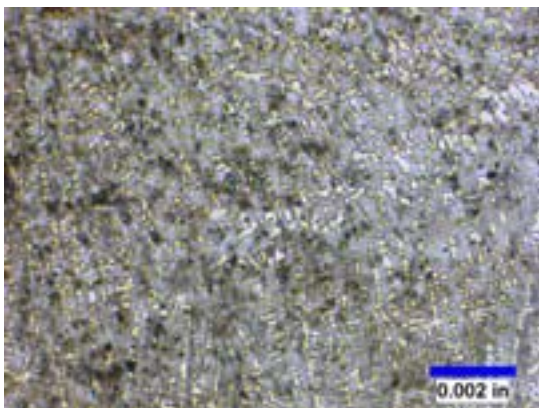
Figure 3. Typical Weld Overlay

(Note: Dark spots are chromium carbide particles)

Due to the relatively “low tech” nature of welding, many of the constraints related to spray coatings are even more relevant to weld overlays. Weld overlay procedures do not typically achieve the same temperatures or particle movement velocities as those attained with spray coating processes. This significantly limits the amount of hard particles that can be deposited for a given amount of carrier material. Typical hard particle volumetric densities for weld overlay materials rarely exceed 28% by volume, the remainder consisting of relatively soft carrier material. While there are many corrosion resistant carrier materials that can be used in the weld overlay process, the nature of such materials (which makes them useful as a carrier in the weld process) precludes them from withstanding high velocity particle erosion. Erosion resistance is directly proportional to the density of the material’s hard particles (see Figures 3 and 4).

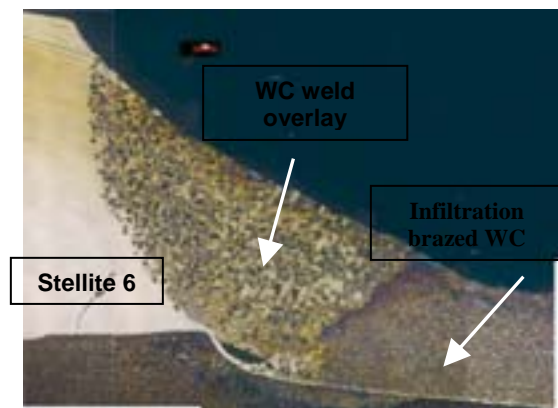
Figure 4. Comparison Mosaic

(Note visible variations in hard particle density)

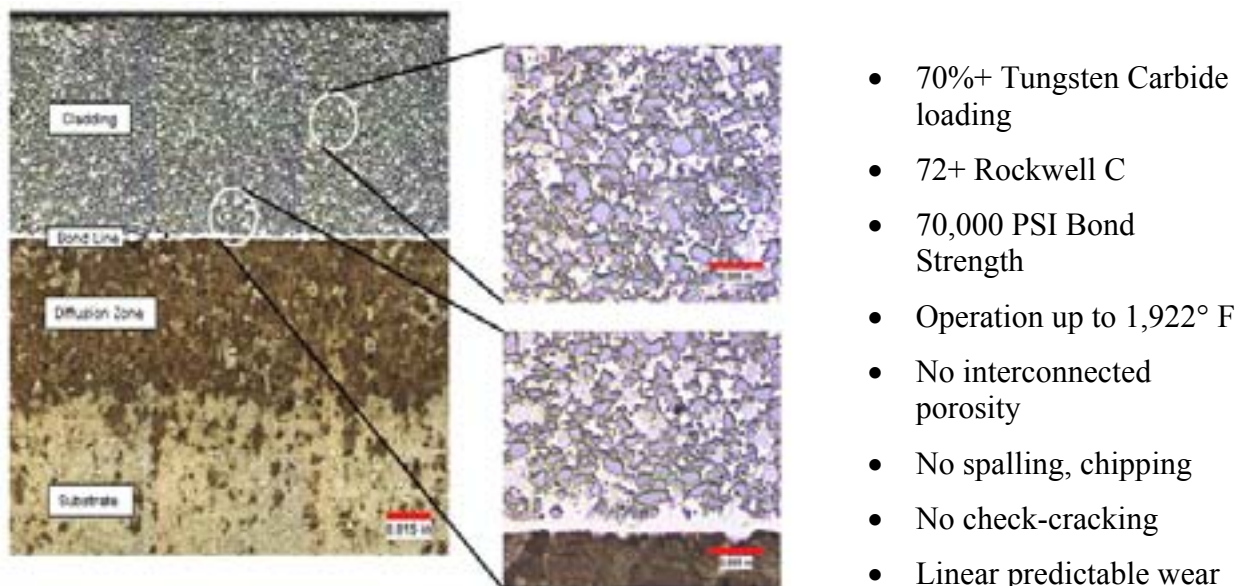
Figure 5. Infiltration Brazed Tungsten Carbide Cladding

- Infiltration brazing does not require the movement of hard particles. Therefore, hard particle densities of more than 70%, by volume, can be achieved (see photomicrograph figure 5).

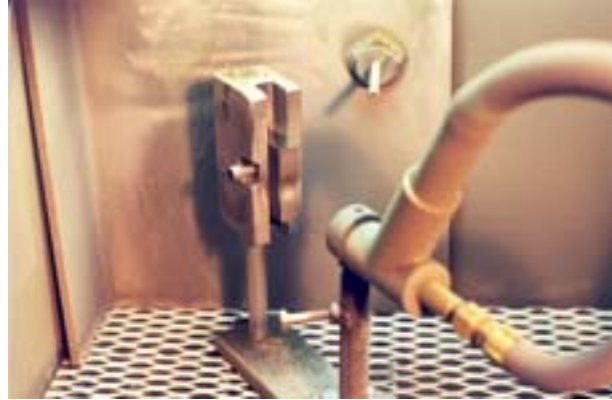
Figure 6. Erosion Testing Fixture

Multiple lab comparisons of infiltration brazed tungsten carbide cladding have been performed in order to benchmark its erosion protection capabilities against other, more commonly known, materials. In December 2003, the Electric Power Research Institute (EPRI) completed a hot erosion comparison utilizing ASTM G73 test methodology. The test, which used fluidized boiler bed ash as the erodent material, compared the following commonly accepted erosion “resistant” materials:

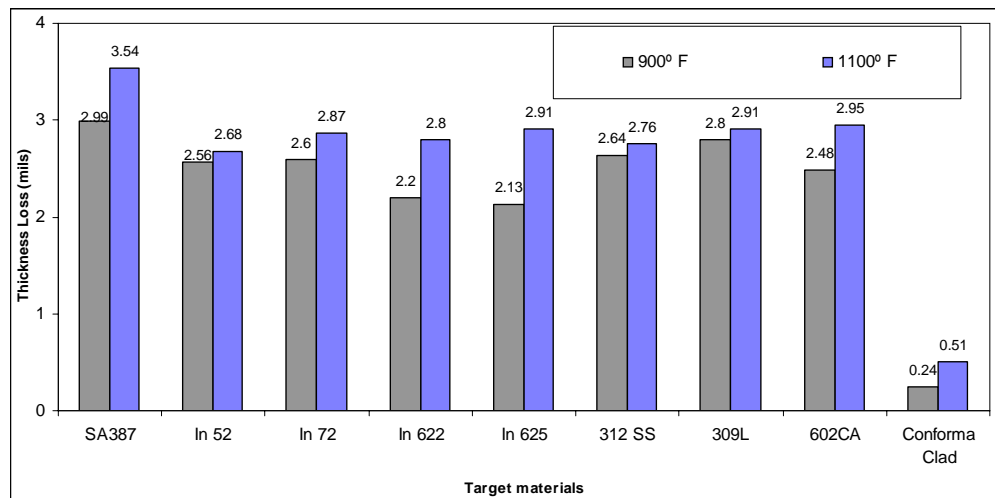
Test Conditions
Particle velocity: 40 m/s
Temperature(s): 900, 1100 F
Impact Angle: 30 degrees
Test duration: 3 hours

Figure 7. EPRI Hot Erosion Comparison Results

Figure 7 indicates that infiltration brazed tungsten carbide outperformed all of the alternative materials, by as much as a factor of ten, in a high temperature ash erosion environment.

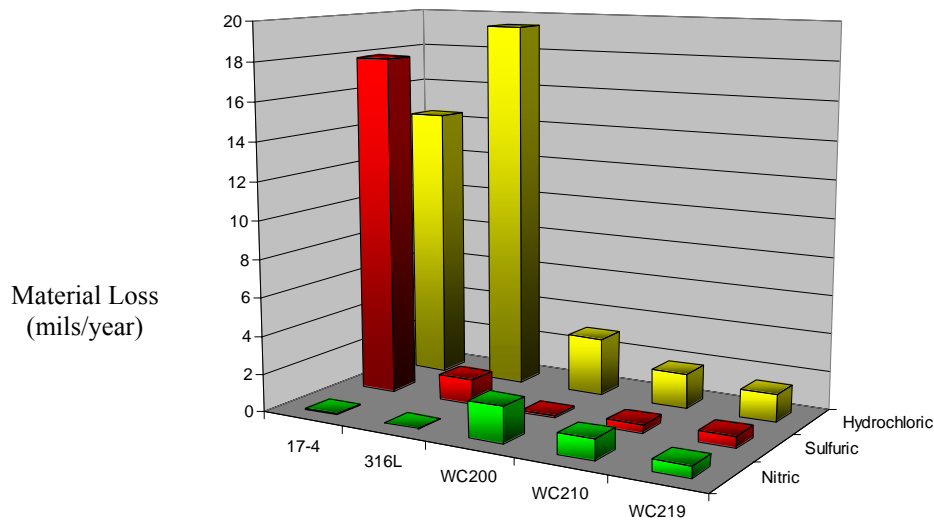
Figure 8. ASTM G31 Corrosion Resistance Results

ASTM specifies a standardized corrosion resistance test methodology referred to as G31. G31 testing exposes a material sample to a 10%, by weight, concentration of boiling corrosive material. ASTM classifies any material as a CLASS A corrosion resistant material if the amount of material lost over the period of one year is less than 0.002". Figure 8 is a graphical representation of the ASTM G31 test results, illustrating that all three primary formulations (WC200, WC210, WC219) of infiltration brazed tungsten carbide cladding are CLASS A corrosion resistant materials in Nitric and Sulphuric Acid environments. All infiltration brazed tungsten carbide claddings, except WC200, are CLASS A resistant to Hydrochloric Acid.

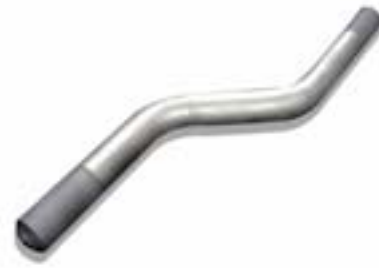
Figure 9. Clad Superheater Tube Leg

The primary superheat tube legs, made of SA210 Grade A-1 material, have an outside diameter (OD) of 2 ¾", with a 0.280" wall thickness. Tube sections have an "S" shaped double bend (see Figure 9), and are approximately 60" in length.

Conforma Clad Inc. received tube sections from AEP, and applied a 0.030" thick layer of its WC219 cladding formulation along an approximately 40" section, centered along the length of the overall tube. It was determined that a thickness of 0.030" provided sufficient protection for the application. Greater thicknesses were evaluated and deemed unnecessary. The cladding layer covered only 200 degrees around the circumference of the pipe, on the upstream side facing the flue gas flow. Coverage on the downstream face was deemed unnecessary.

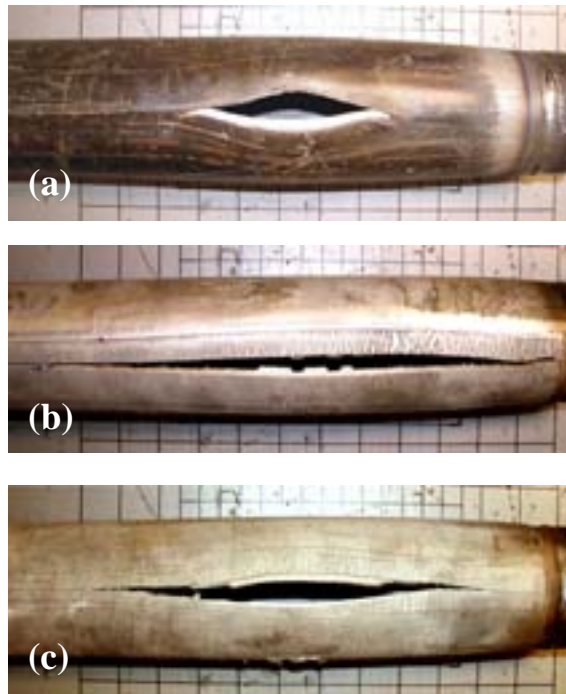
Figure 10. Boiler tube sections after hydrostatic burst test. (a) Control (b) As-brazed (c) Brazed and Normalized.

Data in Table 2 indicates that actual burst pressure, following normalization heat treatment, exceeds the minimum allowable 3,675 PSIG by a factor 3.5X. The ruptured pipes are illustrated in Figure 10. Both of the clad specimens had axial cracks running the length of the cladding, and burst within the cladding.
