## **IMPROVING MILL PRODUCTIVITY WITH ADVANCED WEAR PROTECTION SOLUTIONS**

**Jennifer Broadwater, Conforma Clad Inc.**

### **ABSTRACT**

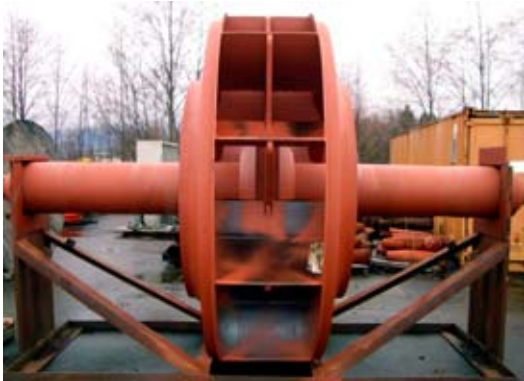
Figure 1. Port Alberni's Power Boiler ID Fan

By-products generated from the power boiler include highly erosive ash and flue gases, which are transported by air to the precipitator, where the fly ash and other particulate matter are removed. The boiler utilizes an induced draft (ID) fan (see Figure 1) to pull flue gases from the boiler and force them through to the precipitator. The mill uses one operating ID fan and one spare fan rotor for the power boiler. The ID fans were manufactured by Baron Industries, and are composed of 10 forward facing curved fan blades. They have a 300cm (10') diameter fan wheel with inlets on both sides, and are propelled by a 1,750 horsepower drive fixed to a Liquid Flo fluid coupling, used to control the 800 RPM fan speed.

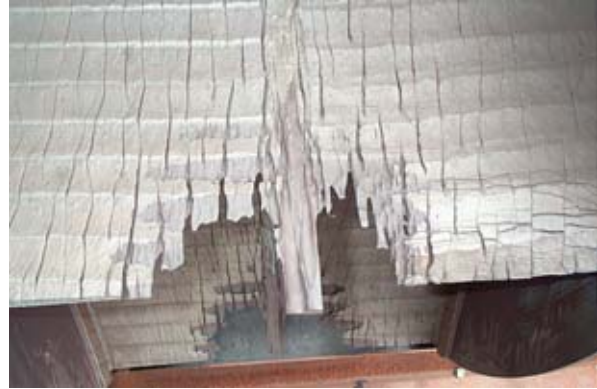
Figure 2. Fan Blades Protected by Chrome Carbide Weld Overlays after Twelve Months in Operation

Prior to 2001, Port Alberni experimented with chrome carbide weld overlays to protect their ID fans from erosive and abrasive wear. During typical fan operation, fine particles eroded through the hairline cracks inherent to hardface weld overlay materials. These cracks provided a less resistive path for erosive materials to wear through the overlay. Portions of the chrome carbide were undercut and began to detach from the fan, as shown in Figure 2. Premature fan deterioration proved costly and inconvenient for mill operators.

The mill operates the ID fan at 75% to 80% of its full capacity. Plant operators began detecting a decrease in fan capacity approximately eight months after installing the ID fan protected with chrome carbide weld overlays. Fan speed was steadily increased to maintain desired capacity. After ten months of operation, the wear and productivity losses exceeded the ability to compensate with increased speed. The fan was unable to achieve required boiler loading for the remaining two months, until the planned outage period. As a result, the steam plant was forced to burn more costly natural gas in their second boiler to achieve the required mill steam load. Over a two month period, these added fuel costs were estimated at \$150,000.

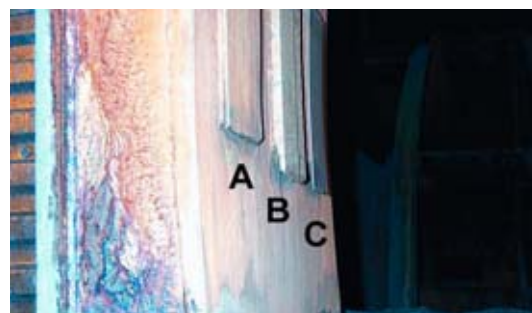
Figure 5. Comparison of Material Lengths after Six Months. A. Alloy Steel, B. Chrome Carbide Weld Overlay, C. Brazed Tungsten Carbide Cladding

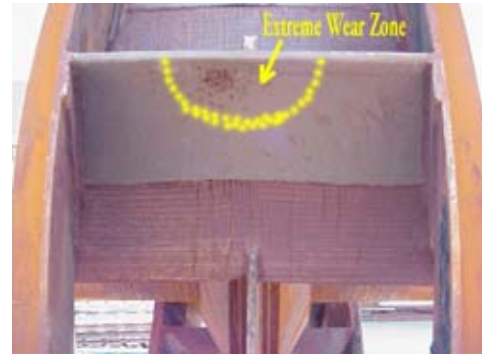
Figure 6. Wear on Fan A after Twelve Months in Operation

In July 2002, Port Alberni installed ten 838mm (33") x 445mm (17 1/2") fan blade liners protected with 1.5mm (0.060") of infiltration brazed tungsten carbide cladding on the operating ID fan (Fan A). Fan A, with components protected by brazed tungsten carbide cladding, maintained optimal capacity through 12 months of continuous operation. In July 2003, a routine inspection of Fan A revealed a wear zone in the middle of the liner's leading edge (see Figure 6).

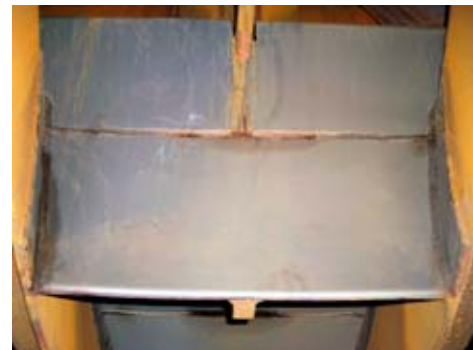
Figure 7. Wear on Fan B after Twelve Months in Operation

Also in July 2003, the mill expanded the brazed tungsten carbide application to their auxiliary fan (Fan B), cladding blades and areas on the center of the support web, which had historically experienced extensive wear. The Fan B application involved cladding ten 838mm (33") x 445mm (17 1/2") fan blade liners, ten 1067mm (42") x 241mm (9 1/2") fan blade liners, ten 503mm (19 13/16") x 584mm (23") fan rib plates and twenty 287mm (11 5/16") x 451mm (17 3/4") fan side plates. The cladding thickness of all fan components remained 1.5mm (0.060"). Fan B also maintained full capacity through 12 months of operation (see Figure 7).

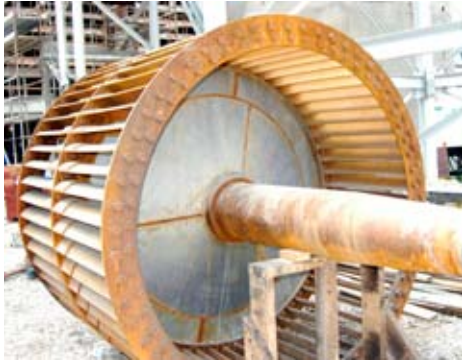
Figure 8. TVA's ID Fan

Fan blades were tested over a sixty day trial period on a double inlet, single exhaust, 400,000 CFM Westinghouse model 16MVID with forward curve fan blades (see Figure 8). Each fan was comprised of 120 blades with a shaft speed of 593 RPM. Wear protected blades were distributed throughout the fan. In order to facilitate balancing, each pair of test blades was installed 180 degrees apart. Because material wear rates were unknown, test organizers were careful to distribute the test blades so that erosion induced weight change would not require fan rebalancing.

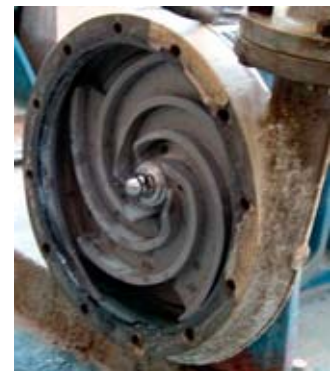
Figure 9. Slurry Pump Protected by Brazed Tungsten Carbide Cladding

Other pulp and paper mills have found comparable success protecting their equipment with brazed tungsten carbide cladding. A mill more than doubled the useful life of their Worthington 90cm (3') x 60cm (2') white liquor slurry pump (shown in Figure 9) from six months to more than 13 months, by replacing their stainless steel protection with brazed tungsten carbide cladding. Another plant improved their productivity by cladding their 900cm (30') lime kiln feed screw. The previous screw, protected by chrome carbide weld overlay, had an expected life of one year with weld repairs every six months. The screw clad with brazed tungsten carbide has lasted over two and a half years and is still in operation.
