# **Improving Mill Performance with Advanced Wear Protection Technologies**

**2004 TAPPI Fall Technical Conference**  
Session 36, Corrosion Prevention  
November 3, 2004; 1:00 pm – 1:30 pm

**Chad Juliot**  
Applications Engineer  
Conforma Clad, Inc.  
[www.conformaclad.com](http://www.conformaclad.com)

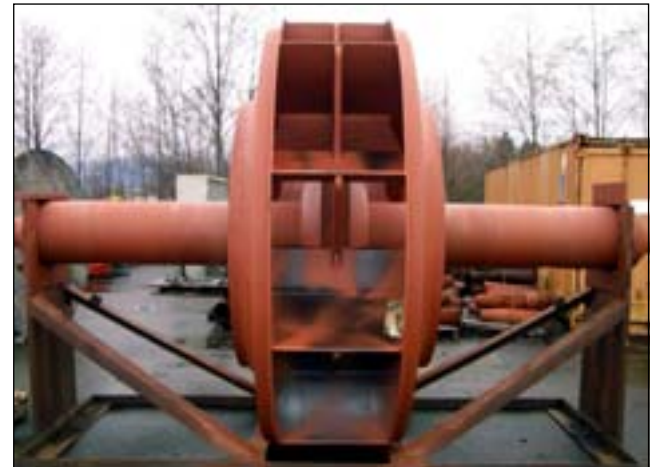
- Induced Draft (ID) Fan
  - Manufactured by Baron Industries
  - 10 forward facing curved blades
  - 300 cm (10') diameter fan wheel
  - 1,750 horsepower drive fixed to Liquid Flo fluid coupling
  - 800 RPM fan speed

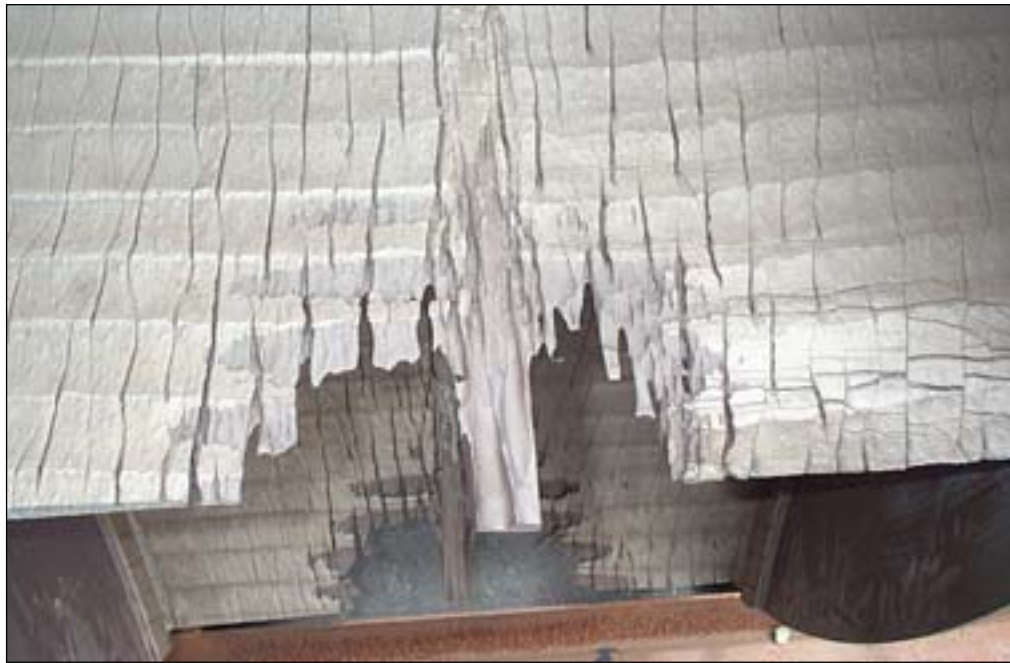
Fan blades protected with chrome carbide weld overlays after 12 months in operation

- Chrome carbide weld overlay protected fan prior to 2001
  - Decrease in capacity detected after 8 months in operation
  - Fan speed increased to maintain capacity
  - After 10 months, productivity losses exceeded ability to compensate with increased speed

- Chrome carbide weld overlay protected fan prior to 2001
  - Unable to achieve required boiler loading for the remaining two months (until planned outage)
  - Forced to burn more costly natural gas in second boiler
  - \$150,000 in added fuel costs over two month period

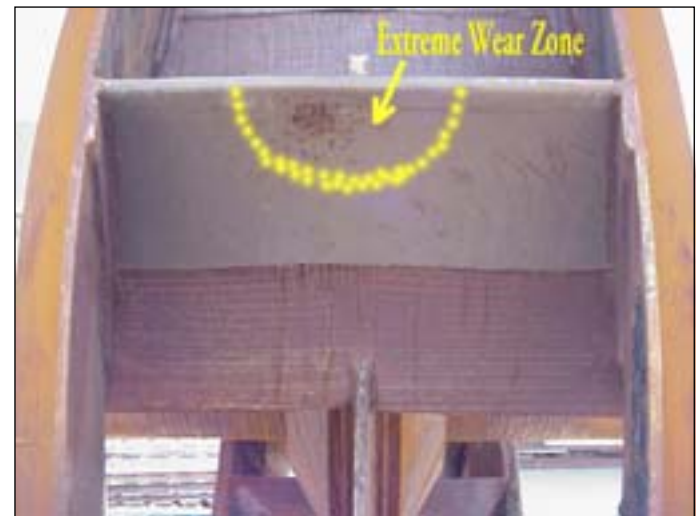
- Fan maintained optimal capacity for 12 months of continuous operation
  - Wear zone detected in middle of leading edge

Wear on Fan A  
after 12 months  
in operation

- June 2004 – expanded Fan A application
  - Installed next generation 838 mm (33") x 445 mm (17 1/2") liners
    - Entire liner clad with 1 mm (0.040") application
    - High wear zone received an additional 1 mm (0.040") of cladding
  - Double-clad liner expected to last two years (due to predictable wear rate)

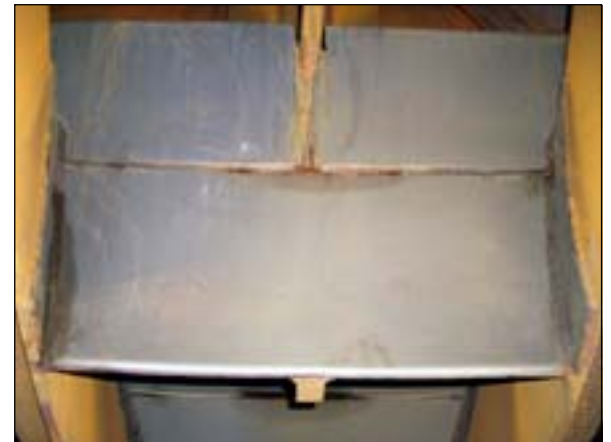
- July 2003 – expanded application to auxiliary fan (Fan B)
  - Protected with 1.5 mm (0.060") of cladding
- Fan maintained optimal capacity for 12 months of continuous operation

Wear on Fan B  
after 12 months  
in operation

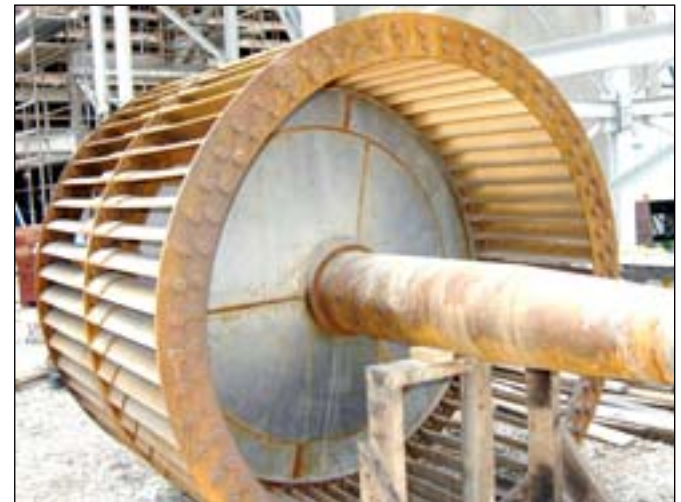
- EPRI/TVA Kingston Power Plant Study
  - ID Fan
    - Double inlet, single exhaust
    - 400,000 CFM Westinghouse model 16MVID
    - Forward curve fan blades
    - 120 blades per fan
    - Shaft speed = 593 PRM

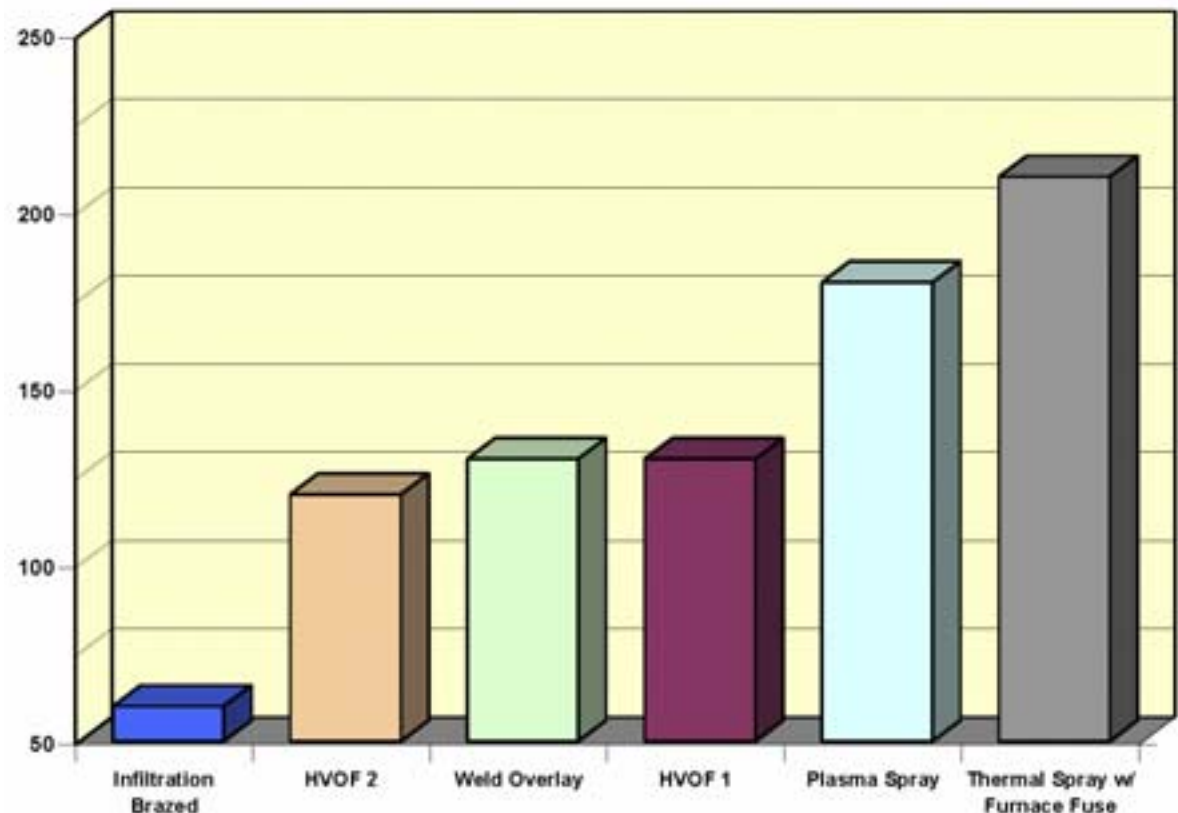
Wall loss  
after 69 days

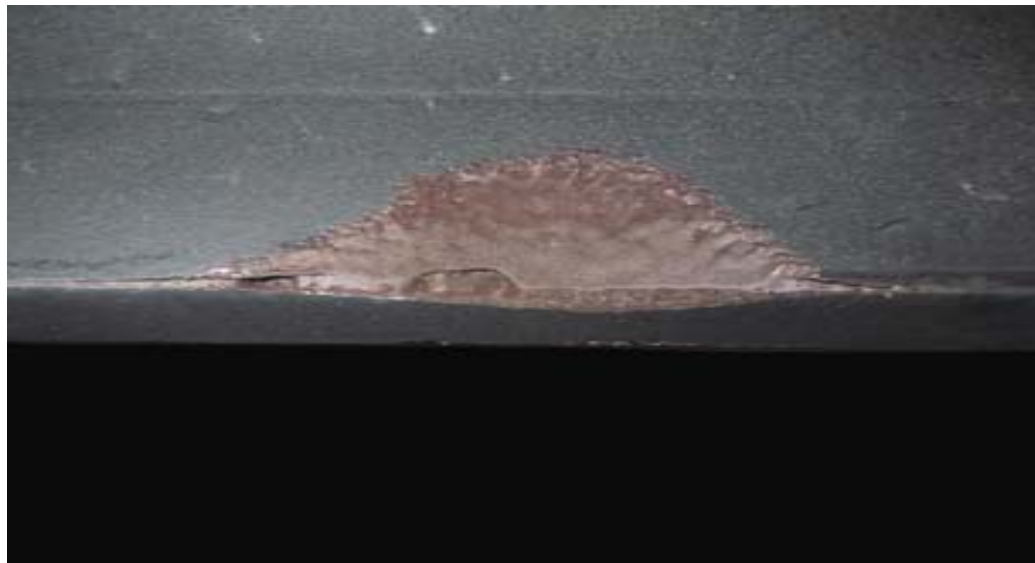
- EPRI/TVA Kingston Power Plant Study
  - Test Results
    - Tungsten Carbide HVOF

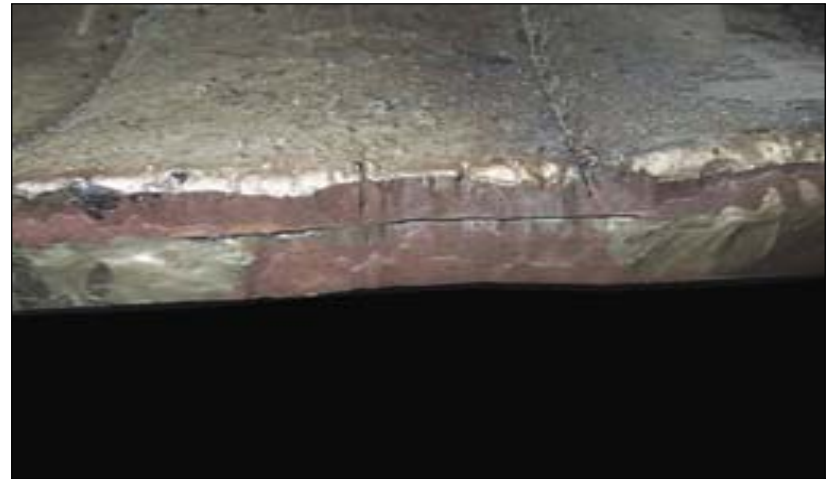
- EPRI/TVA Kingston Power Plant Study
  - Test Results
    - Chrome Carbide Weld Overlay
      - Material loss of 3 mm (0.12")
      - Crack at center of junction plate

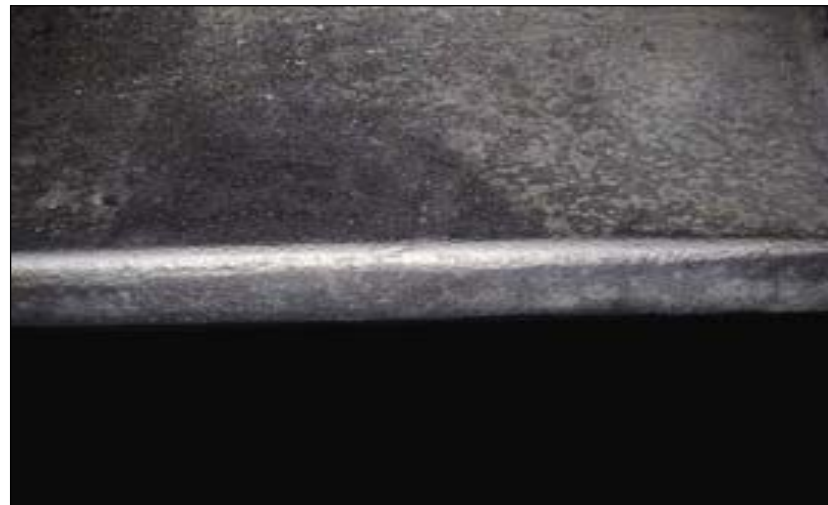
- EPRI/TVA Kingston Power Plant Study
  - Test Results
    - Infiltration Brazed Tungsten Carbide Cladding
      - Material loss of .25 mm (0.010") at leading edge

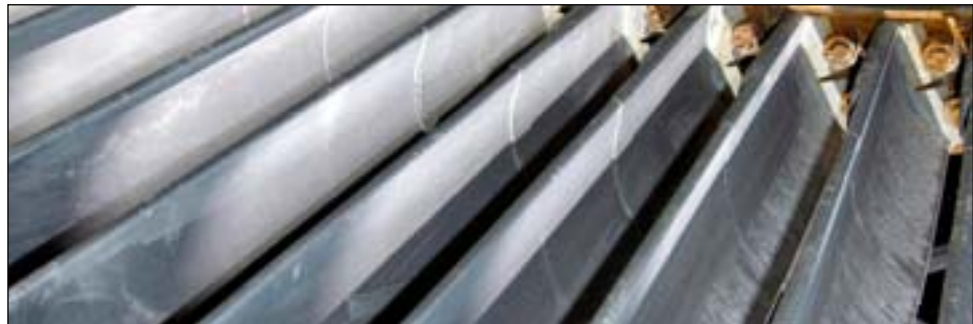
- EPRI/TVA Kingston Power Plant Study
  - Kingston installed ID fan blades clad with brazed tungsten carbide in boiler Units 5-9
    - Blades installed October 2002
      - After 7 months run time, blades showed material loss of .4 mm (0.014") or less.
    - Expected life > 24 months
      - Four times life of unprotected fans

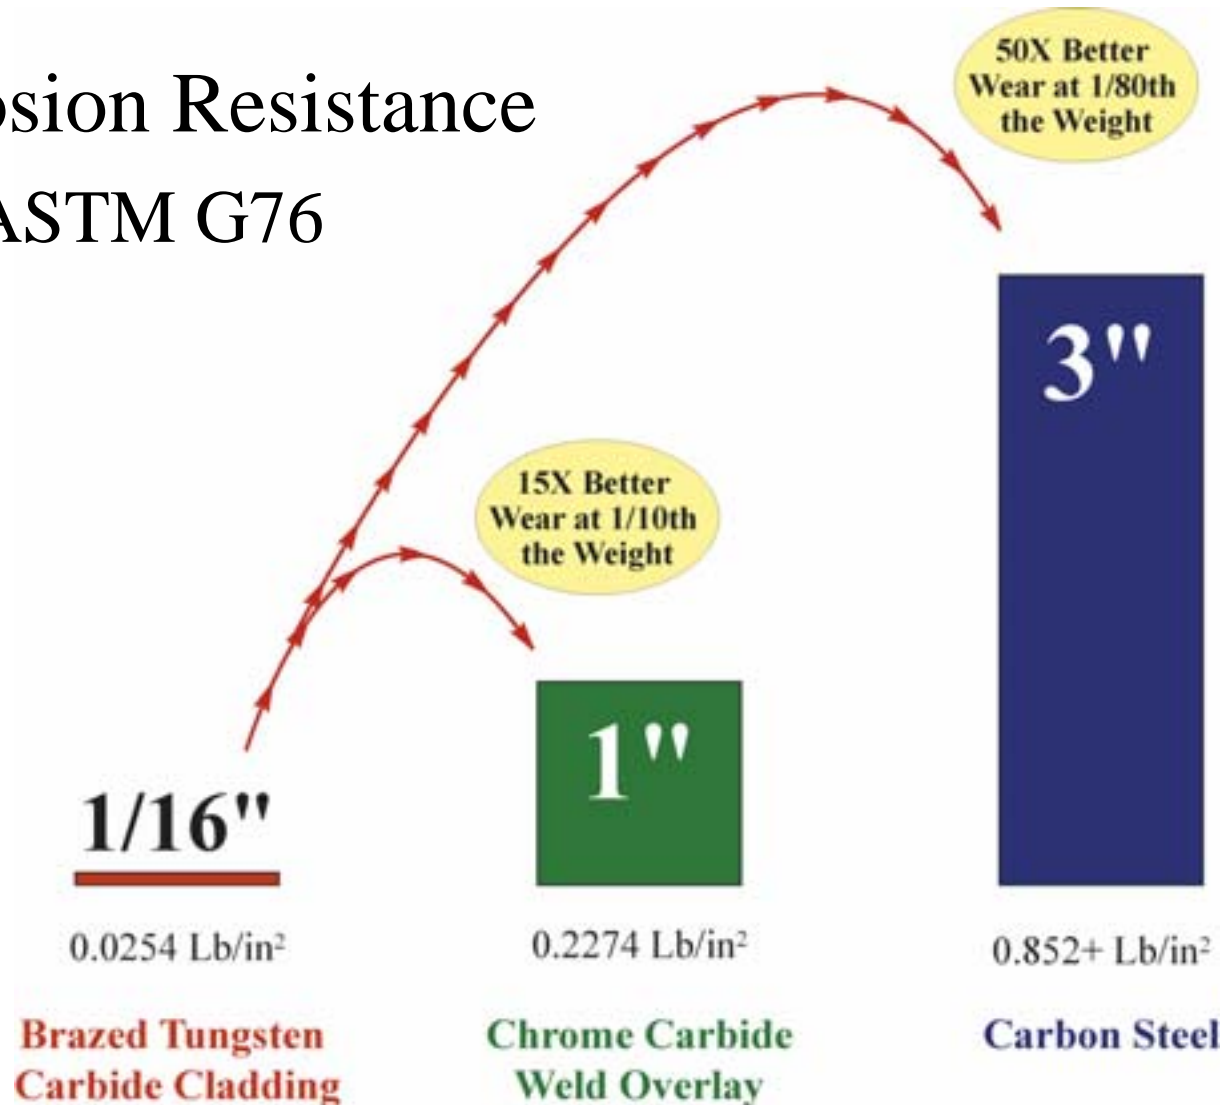
- Erosion Resistance
  - ASTM G76

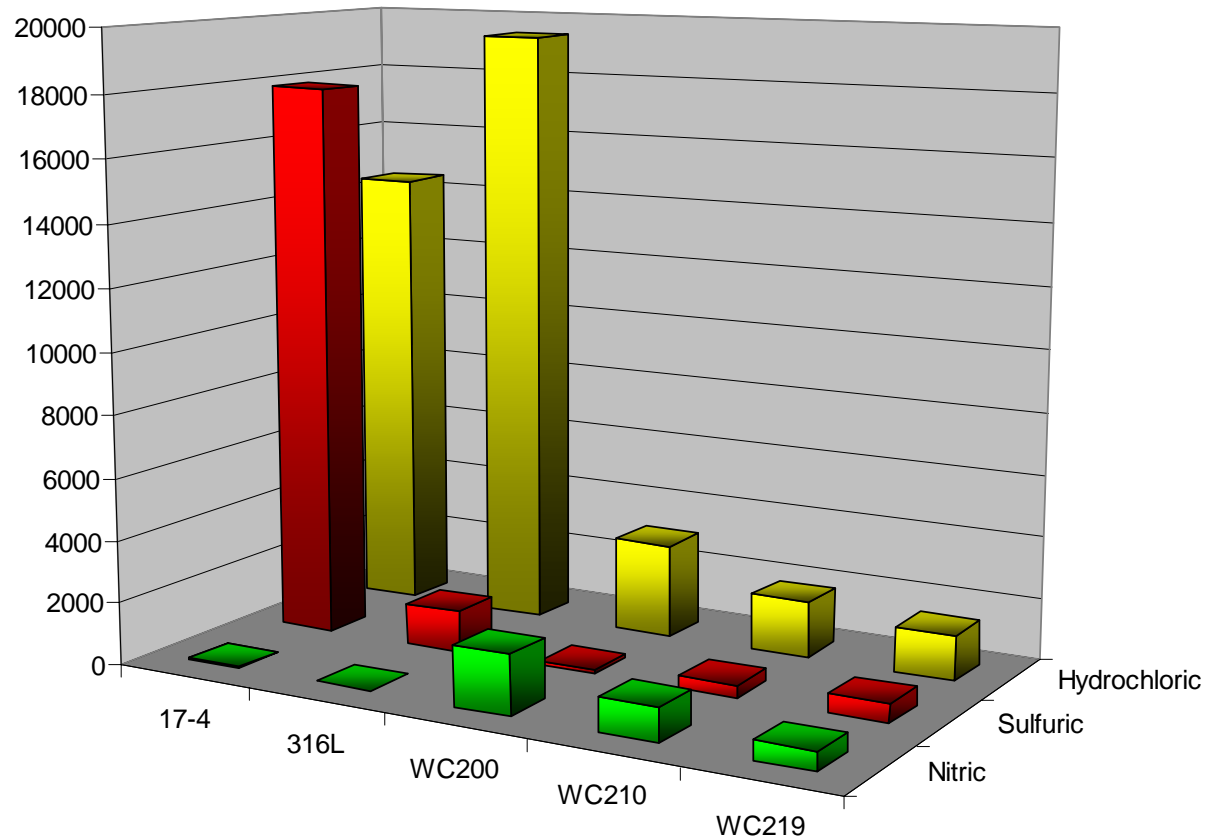
- Corrosion Resistance
  - ASTM G31

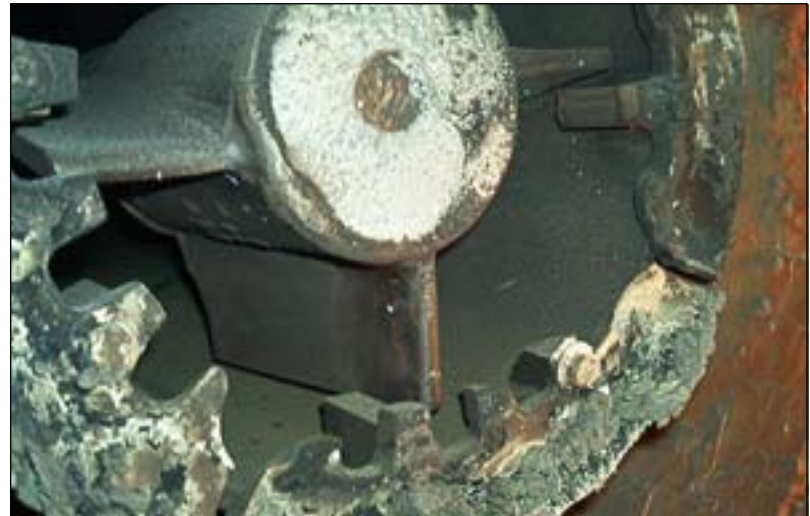
- Power Generation - high velocity burner application - under severe thermal shock
  - Burner component coated with Stellite 6 experienced 38 mm (1 1/2") of erosion from leading edge after 22 months service

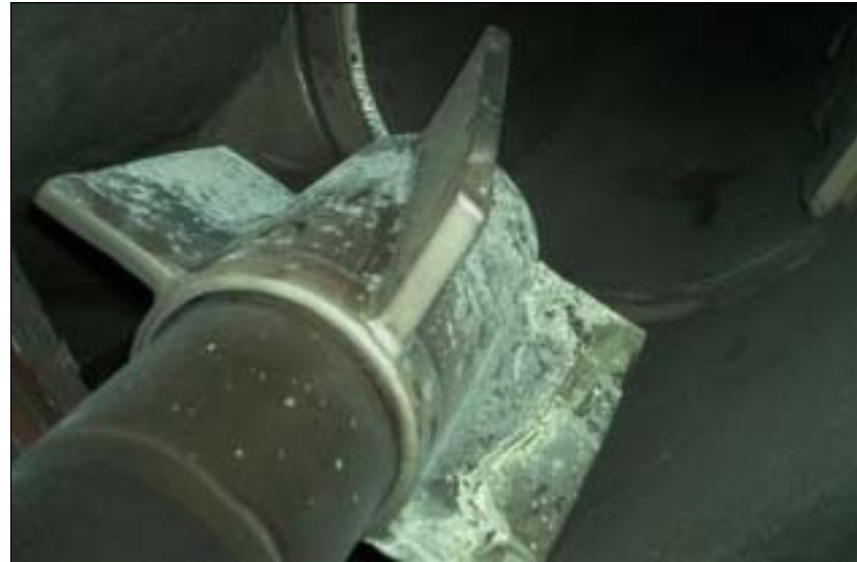
- Power Generation - high velocity burner application - under severe thermal shock
  - Maximum material loss of infiltration brazed tungsten carbide clad component was only .2 mm (0.007")

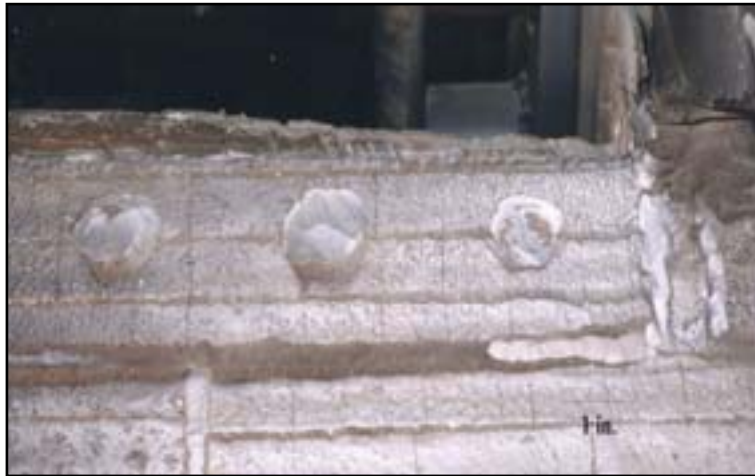
Vanadium Carbide Weld Overlay After 14 Months  
(19 mm ( $\frac{3}{4}$ " ) eroded from leading edge)

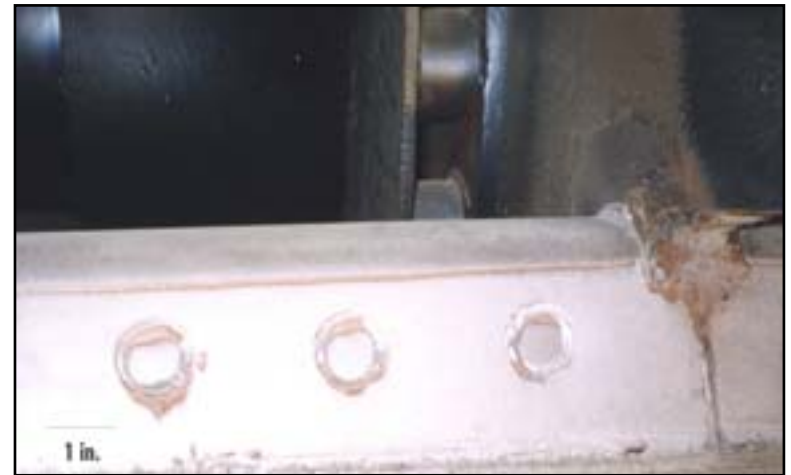
Brazed Tungsten Carbide Liner After 14 Months  
(no visible wear)

- AEP/CINERGY Zimmer Power Station, Unit 2, Gas Recirculation Fan
  - Infiltration brazed tungsten carbide cladding extended runtime between outages from 14 months to more than 3 years

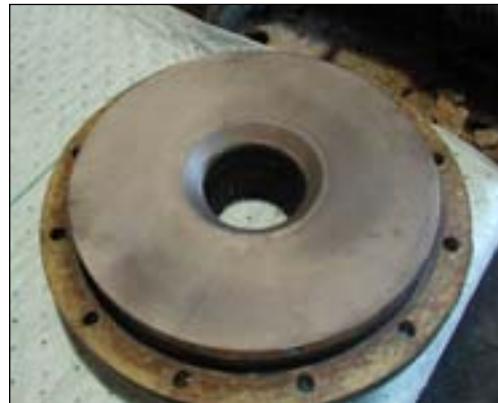
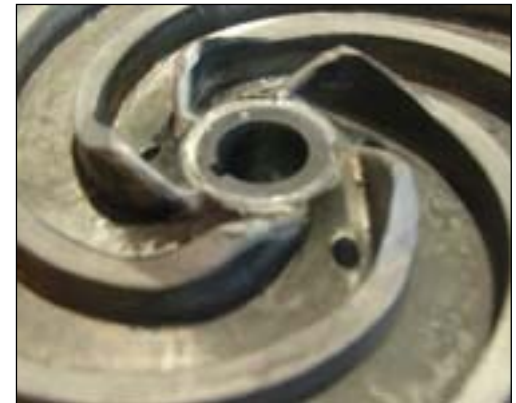
- Worthington 90 cm (3') x 60 cm (2') white liquor slurry pump
  - After 6 months in operation
    - No detectable wear on internal surfaces
    - .1 mm (0.005") wear on 45° chamfer & on impeller tips

- Worthington 90 cm (3') x 60 cm (2') white liquor slurry pump
  - 45% Solids, 14 pH
  - Life with stainless steel protection = 6 months
  - Brazed tungsten carbide cladding increased life to > 13 months
  - Predicted life of clad pump > 36 months
